Jose Rizal Park

S. Judkins Street and 12th Ave S.

LOCATION AND VIEWPOINT CATEGORY

SUMMARY OF EXISTING CONDITIONS

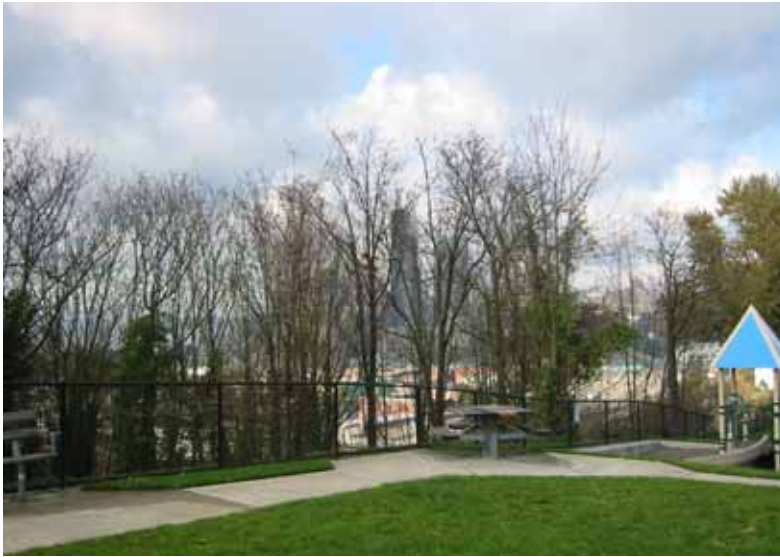
Obstructed views from the Jose Rizal sculpture and playground

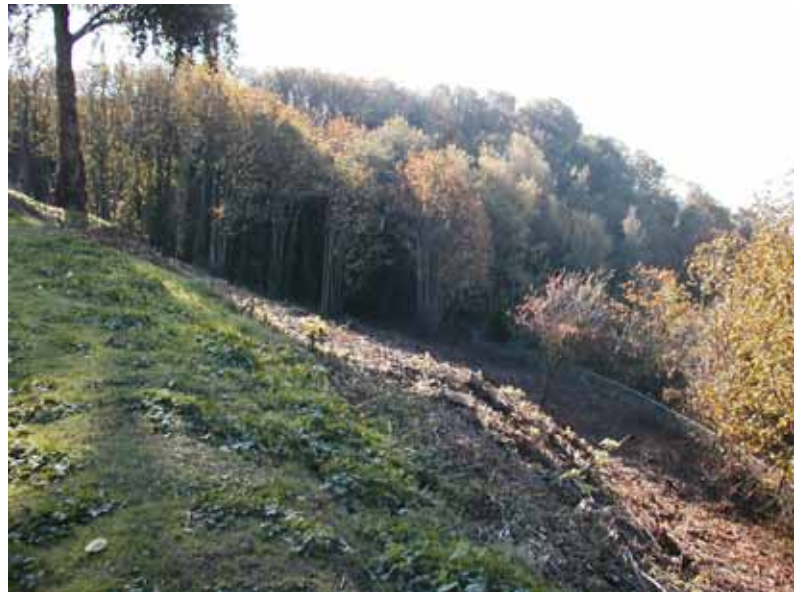
Exposed unvegetated slope, facing south to adjacent trees

1. Remove regrowth of blackberries
2. Cover any exposed soil with mulch
3. Plant layered vegetation on Hillside Zone 3. Care should be taken not to mix woodchip brush with soil during planting.
4. Plant low hedge along Transition Zone 2
5. Mulch all new plantings where needed
6. Provide temporary irrigation

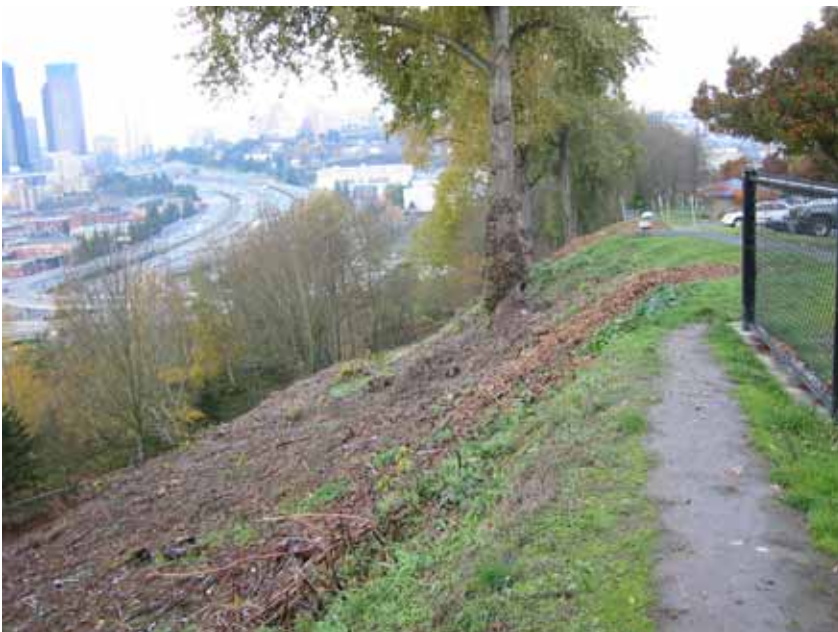
Cleared slope prepared for restoration planting

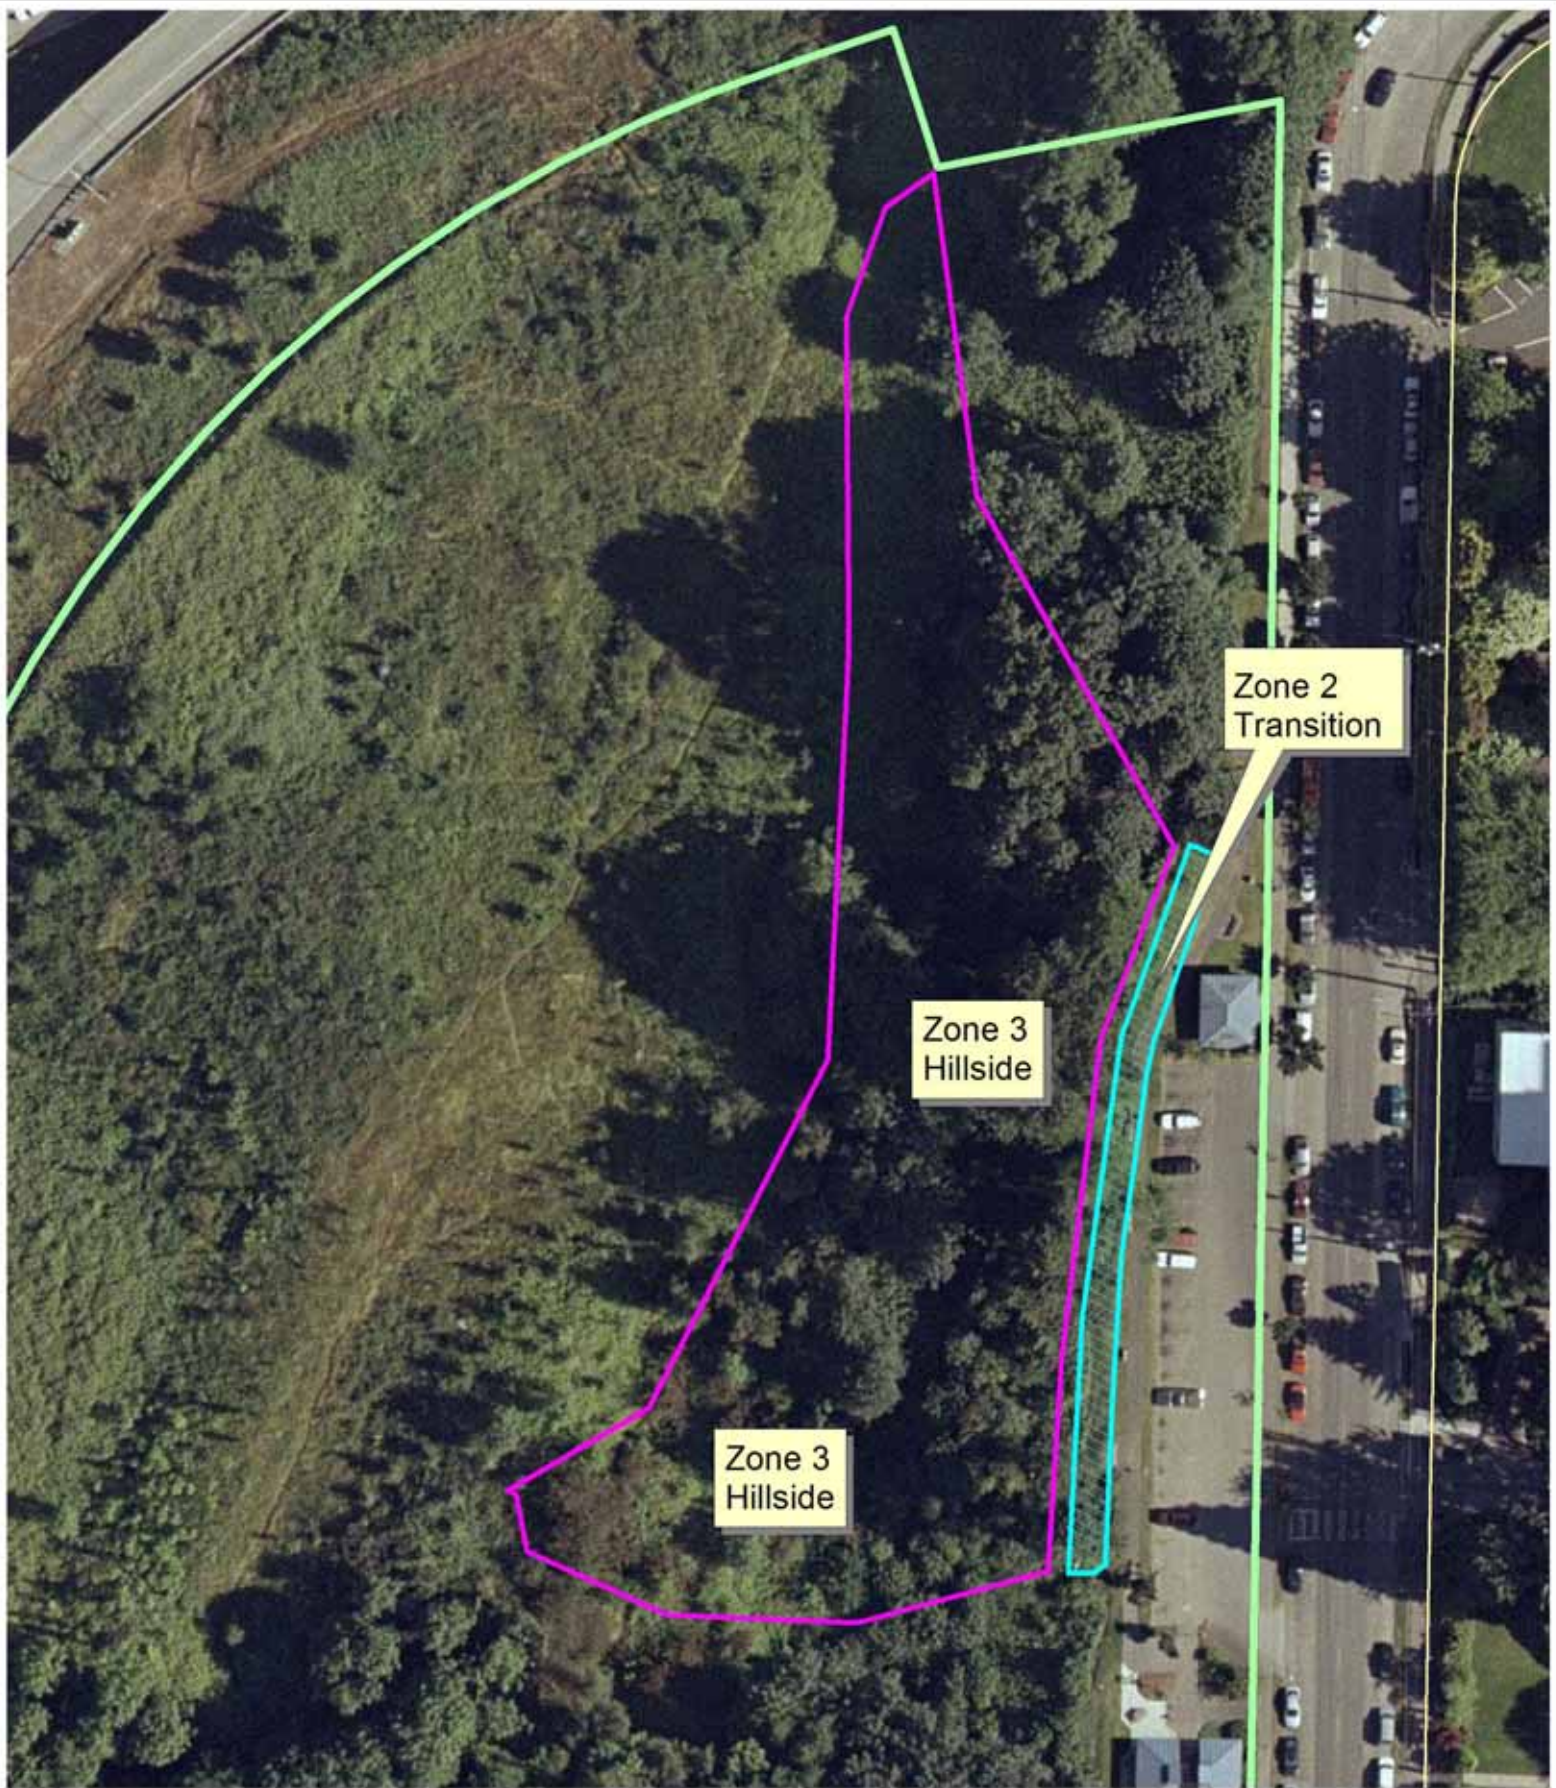
Rizal Park Viewpoint

LANDSCAPE MANAGEMENT ZONES

- Zone 1 - Developed Park Landscape
- Zone 2 - Transition
- Zone 3 - Hillside
- Park Boundary
- Parcel Boundary

Zone 2 - Transition area at the crest of the slope

Zone 3 - Hillside
